Urgent warning about permanently installed quick draws and carabiners in climbing areas

Mammut is urgently calling for the immediate discontinuation of use and removal of permanently installed quick draws and carabiners in climbing areas. Irrespective of the manufacturer of such equipment, repeated wear can result in the formation of sharp edges capable of damaging or completely severing ropes, even in relatively small falls.

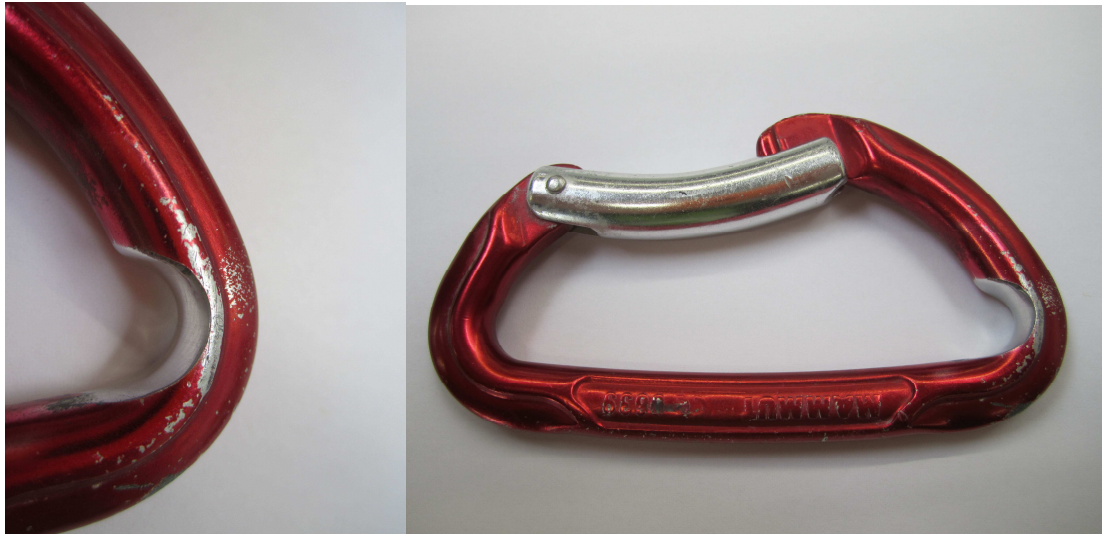
Depending on their position, as a result of friction from climbing ropes when lowering climbers, these quick draws can be worn to a blunt angle resulting in the formation of very sharp edges (see figure 1).

Wear is increased by the presence of dirt or sand on the rope. Extremely sharp edges form on carabiners which almost never bear the load of a fall and are rarely used as a turning point. This means that they are never "deburred" (worn to a rounded shape) and razor-sharp edges can develop. Carabiners with a T-profile tend to be more prone to the formation of sharp edges in comparison with round profiles.

In tests in the Mammut standard fall facility on the carabiner shown in figure 1, it was found that a 9.5 mm rope with fall mass of 80 kg severed at a fall height of just 2.7 meters/fall factor of 1.0. The carabiner used had an extremely sharp edge. Previous investigations have also shown that, in practice, friction in the safety chain can result in a fall factor that is significantly higher than the calculated value. In combination with a very sharp carabiner, even very small falls with a fall height of less than a meter can be critical. Several cases of cut ropes without grave consequences are known. Presently this is being researched as a possible reason for a fatal climbing accident in Switzerland.

Figure 1: carabiner with sharp edges created through friction from climbing ropes.

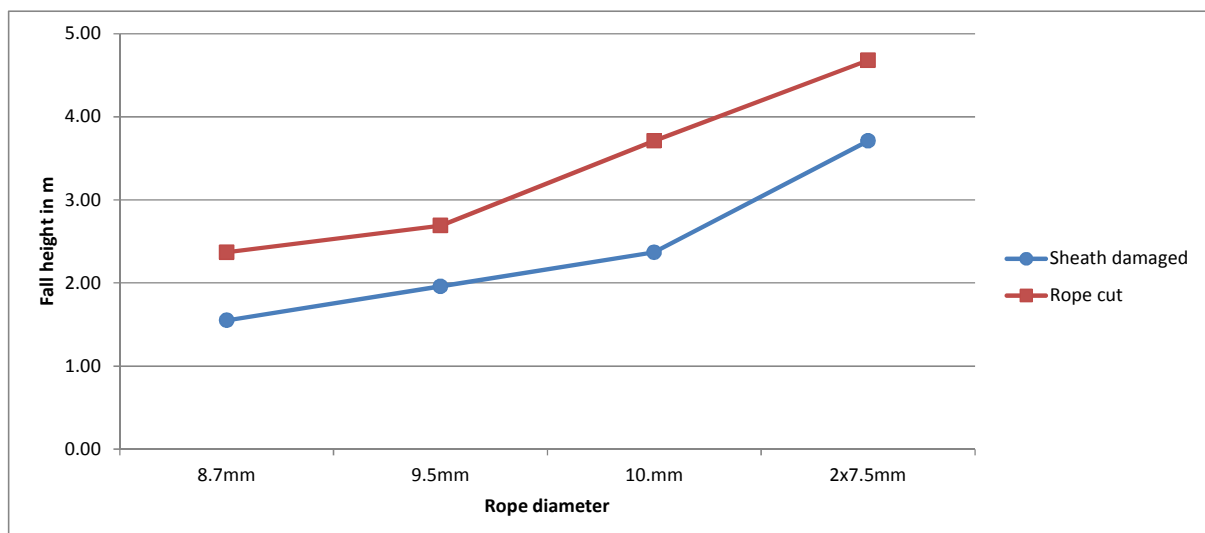
Mammut also examined the effect of the rope diameter on these sharp edges. A clear connection emerged, as shown in graphic 1: in all cases, a thicker rope offers a higher safety margin in relation to sharp edges. However, even with a 10 mm rope the values are critical and life-threatening. Twin and half ropes (both ropes clipped) offer the highest safety margins. No significant differences were observed between the values for used ropes (light furring on the sheath, no damage) and new ropes.

Figure 2: Rope damage for different rope diameters depending on fall height. Anchor point using sharp-edged carabiner from figure 1. Fall mass 80 kg, rope length paid out 2.64 meters. Mammut Sports Group, October 2012.
